# DAB SFN - Single-frequency network SFN errors

Christian Strøm Broadcast System Architect
Telenor opperates 2 national DAB networks in Norway

- Comercial nettwork 250 Tx, 93,5% population coverege
- Puplic broacaster 1070 Tx 99,7% population coverege

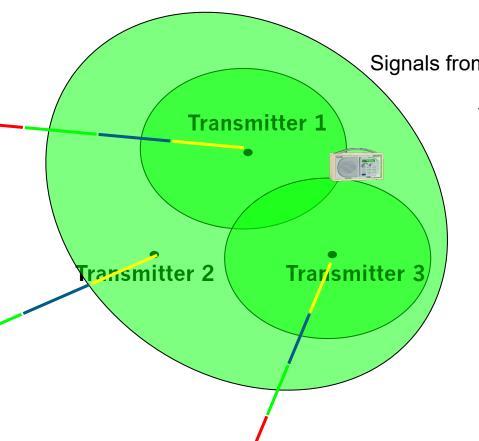
Signals from each transmitter will be added in the receiver.

This can be avoided/reduced by delaying some of the transmitters

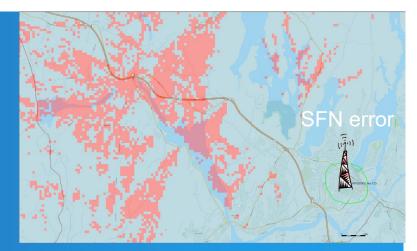
If one transmitter has timing issues

=> It will transmit signals at the wrong time

- => The output will cause self-interference in some areas.
  - Listeners will complain that there is no signal.
  - Close to the transmitter reception will be OK
  - You need to go out in the field and look at the impulse response

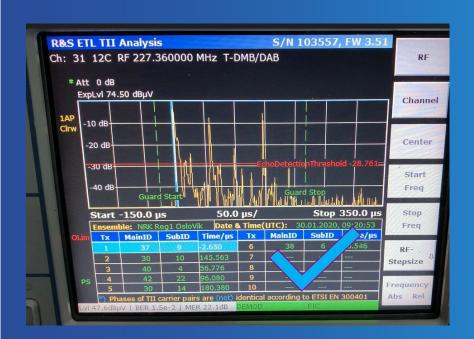
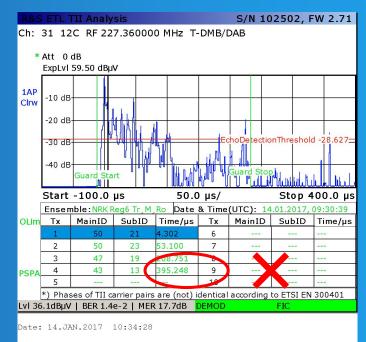
## Results using R&S ETL measuring equipment

Transmitter ID TII 43 13 - Sarpsborg
